## Galaxy TDI – Intake Manifold Cleaning

Removal and cleaning of the intake assembly. (VW PD Engines)

Version: V1.07  
06/07/2011

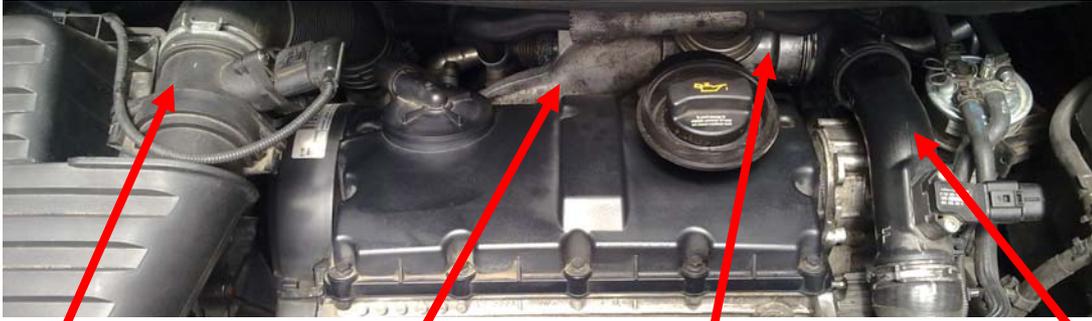
**Location:** (Engine cover already removed)

**MAF**

**Intake Manifold**

**EGR Valve**

**MAP Pipe Section**

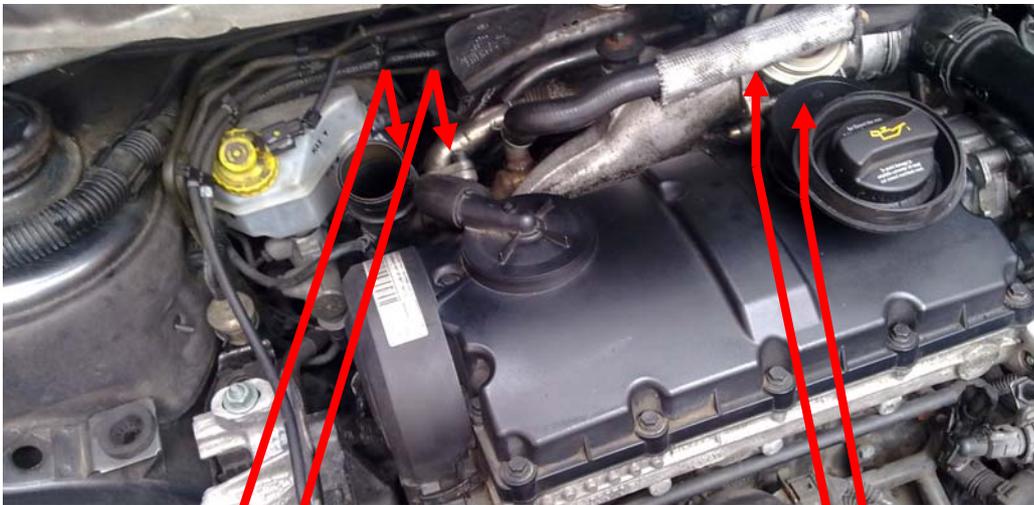
The next task is one of the awkward ones! Remove the EGR Heat Exchanger (HE) output to valve pipe. Its 4 allen bolts in total taking care to recover the gaskets:

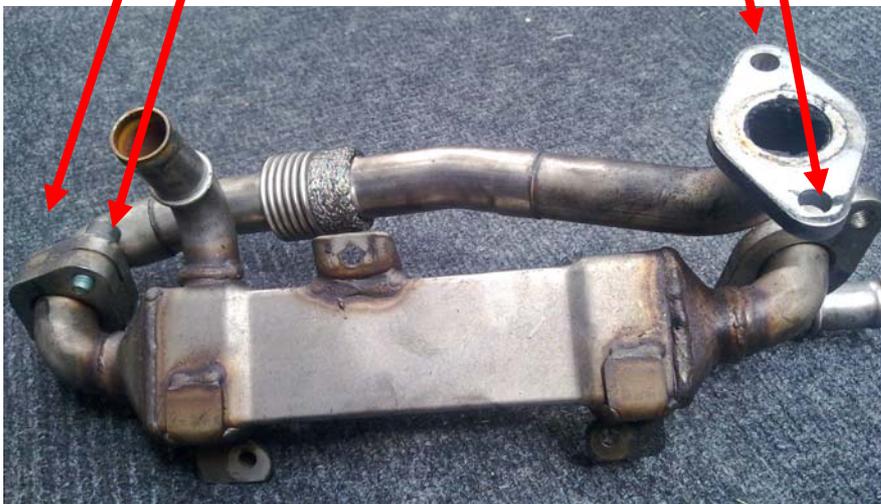
With the HE off the vehicle its

easier to see where the 4 bolts are:

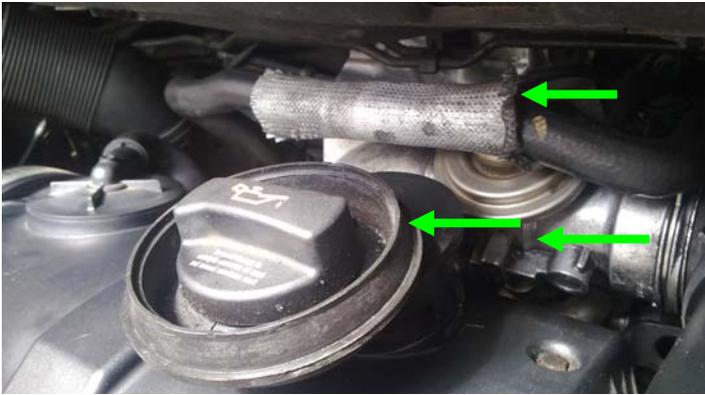
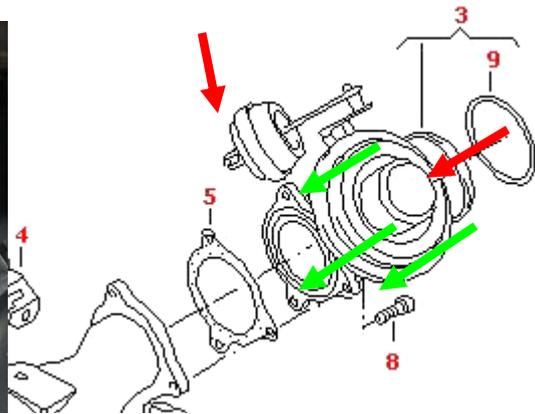
With this pipe removed you now have access to the 3<sup>rd</sup> retaining bolt of the EGR Valve which is next to be removed. Disconnect the two vac pipes going into the valve (red) and the bolts (green) – again they are tricky to access. Lift out the EGR valve assembly.

The valve assembly is where the mixing starts, so don't be surprised to find some standing oil on right side and a very gummed up left side. Next, remove the turbo downpipe retaining bolt (red) from the side of the manifold and then the three bolts (blue) that hold the EGR cooler to the back of the manifold together with the two bolts holding the final piece of EGR pipe work to the cooler.

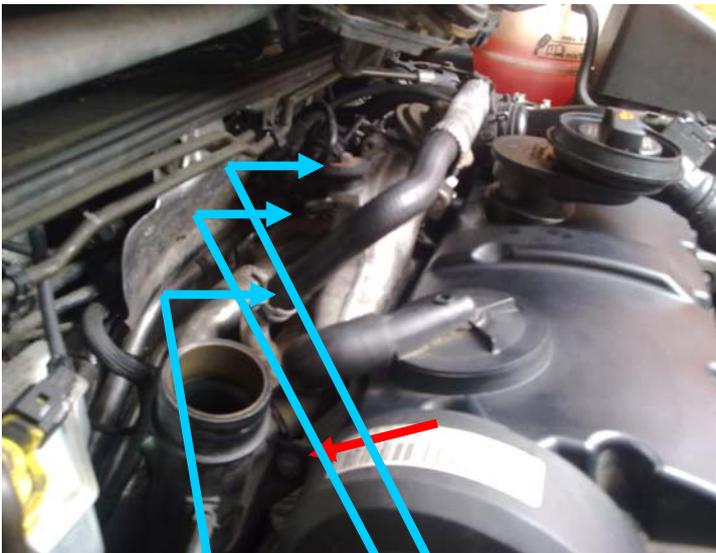
These are easier to see but again, photography wasn't easy so this is the view of the back of the manifold assembly, referenced with the HE view from earlier.

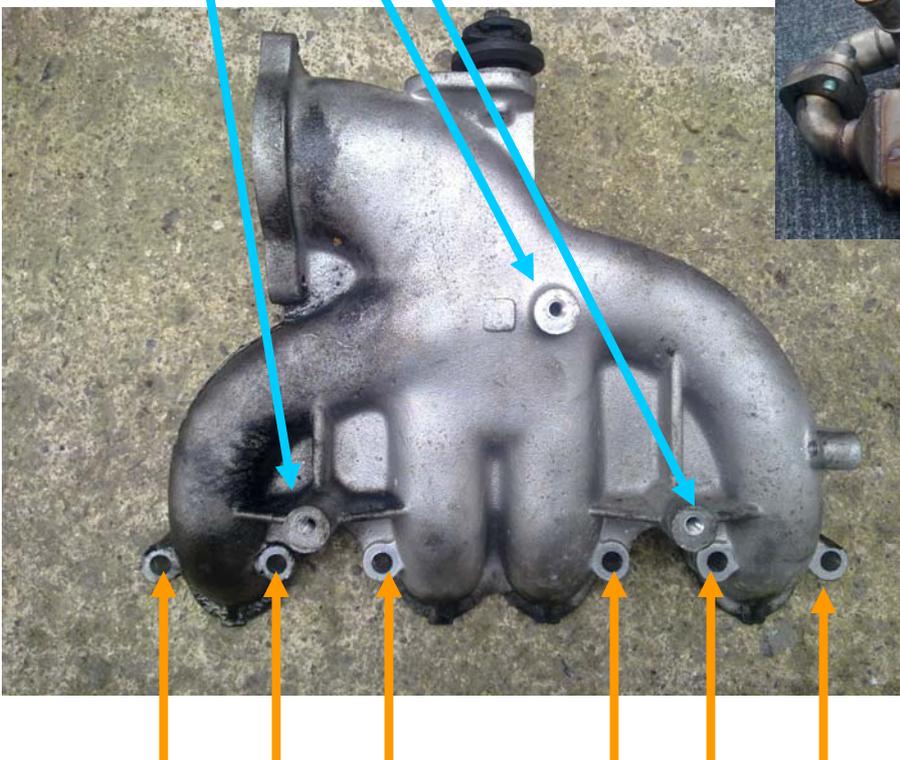
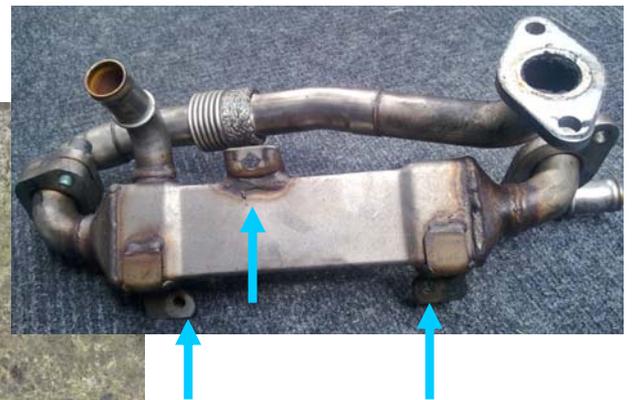
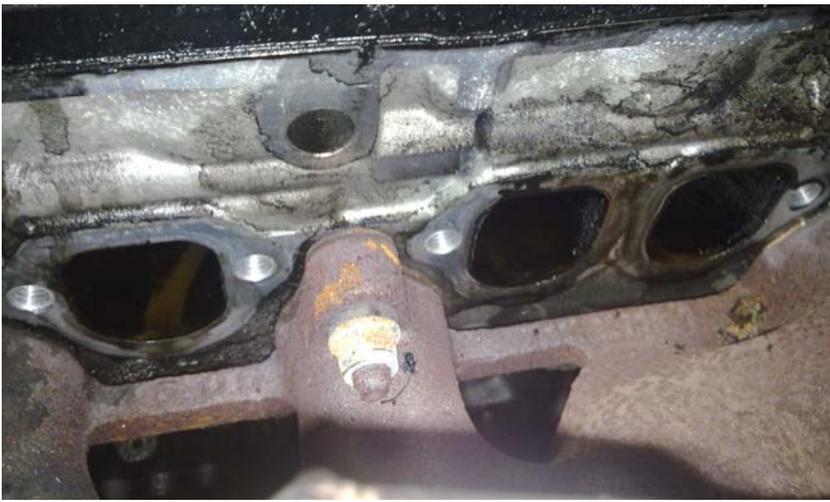
With the HE now free to move the final stage is to remove the 6 allen bolts that hold the manifold to the head (Orange) Again recover the gasket at this point. Note where oily residue has been leaking from the EGR system down the back of the manifold and also where the intake gasket appears to have been leaking between ports 2 and 3 (below)

With the manifold removed it's now time for the cleaning and de-gunking of the assembly. It's easy to forget this stage later on so start by using a clean rag to wipe around the back of the cylinder head against where the gasket will seat. Care should be taken that nothing falls into those inlet ports including debris and solid particles from the surrounding area but a clean surface is essential for a good seal when the unit is refitted.

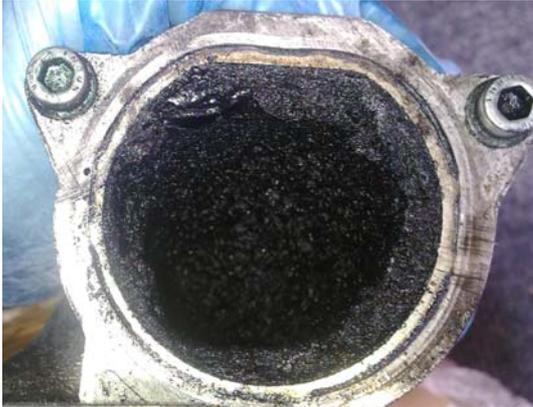
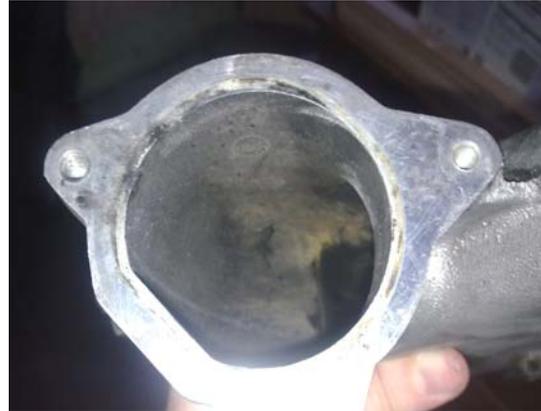
The car this manifold is from is a 2003 TDI with 70K on the clock

The two photos above show the intake to the manifold before and after, you can see the volume of contamination that's built up here which is severely restricting airflow. Below is a closer photo of the same intake with a small section scraped away, it aids to show just how thick the sludge is measuring at 6mm thick at this point. To the right is the port outlets which have fared a little better but the build-up here is still over 2mm thick – more interestingly is that the build-up is less on ports 3 and 4 which could have given an imbalance in intake air and potentially the cause of the increased idle.

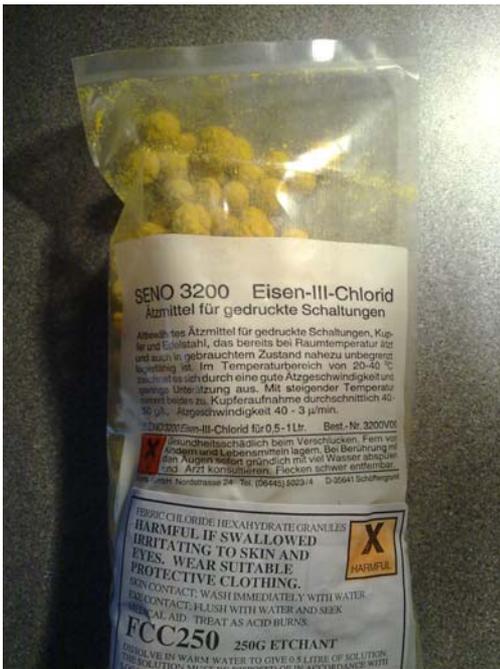
Cleaning out this assembly is a messy old affair so be warned! Use a screwdriver to scrape out as much solid debris as possible and then the wire brush to get back to metal. Try and get into as many areas as possible but be careful to avoid doing damage to the mating surfaces.

Experimenting with various chemicals found that Ferric Chloride was reasonably effective at eating through the left over debris but if you do plan on using it remember that its an acid/etchant so protective equipment **MUST** be worn.

Mix up enough solution to allow it to be lightly poured into the upturned manifold and then, using a paintbrush, work it over the remaining surfaces. Leave it for a few minutes to work before washing out and repeating again.

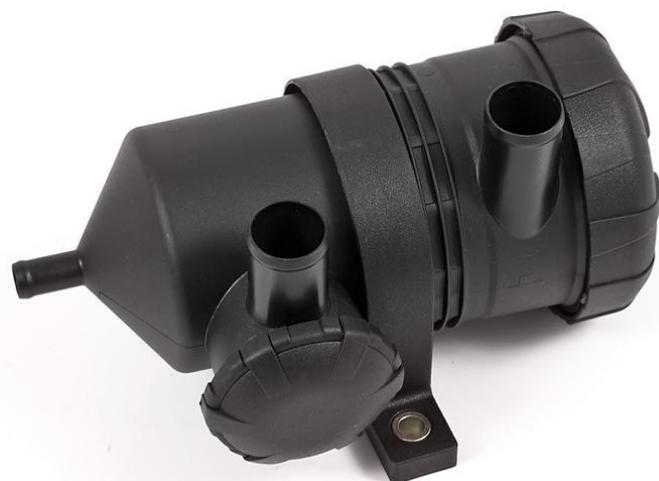
A more sophisticated way to deal with the problem is to separate the oil from the air vapour as it leaves the CCV system. There are a few products that do this but the most effective seems to be the MANN and HUMMEL ProVent System, this filtration system extracts the oil vapour allowing clean air to pass back into the inlet. Without oil the sooty air entering the tract from the EGR system won't stick and instead be consumed as normal without coating the intake.

At the time of writing the provent system had been ordered for this vehicle but had not yet arrived for installation. Further information to follow.
